MARINE CASUALTY REPORT

TANKSHIP PUERTO RICAN

EXPLOSION AND FIRE
IN THE PACIFIC OCEAN,
ON 31 OCTOBER 1984

MARINE BOARD OF INVESTIGATION REPORT

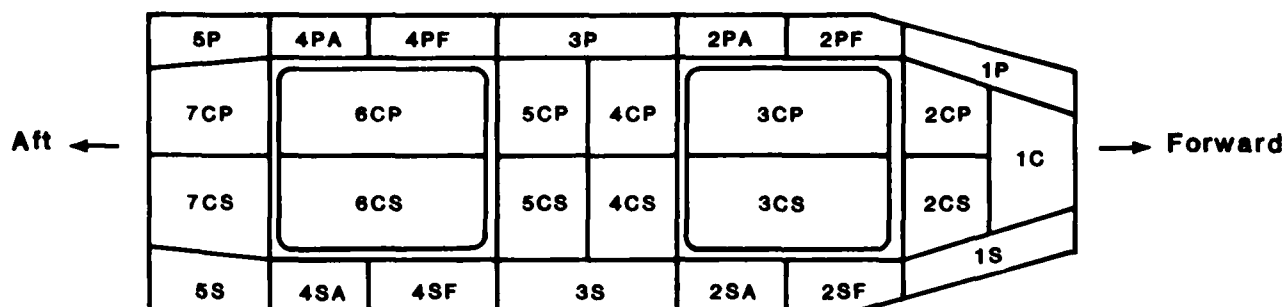
Figure 1. Schematic plan of cargo tanks on the S.S. Puerto Rican.

7. The PUERTO RICAN was a steel tank vessel with special tanks and tank linings for the carriage of specified chemicals and liquefied gases. The deckhouse was located aft and above the machinery space. It contained the navigation bridge, radio room, and quarters for the entire complement of officers and crew. An educator room, located below the main deck on the centerline of the vessel between the engine space and the aftermost cargo tanks, serviced the double bottom sea water ballast tanks. The cargo control room was located on the port side of the main deck centerline next to the foam room and immediately forward of the deckhouse. The forebody was divided into 27 cargo tanks. The cargo tank arrangement and numbering system is shown in figure 1.
